SCOOP Crosstests evaluation – first series

Deliverable

Activity 4 : Cross Tests

Publication Date: 30/12/2019

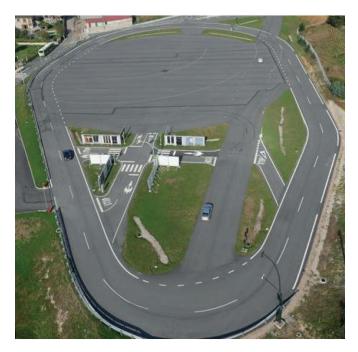
Figure 8 Test track at CTAG facilities

The aim of this scenario was, as a first step and before proceeding with open road field tests, to allow participants to perform some initial tests to validate their vehicle setups and configurations for executing the different test scenarios.

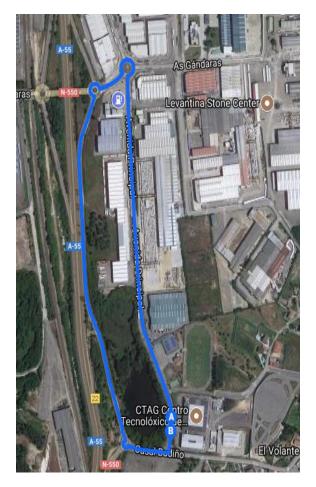
Figure 11 V2V Scenario location

The aim of these scenario was to perform V2V tests among the participant partners. Tests were carried out both in the V2I scenarios and also close to CTAG premises where both static and dynamic V2V tests with vehicles can be performed in a real environment but under controlled conditions avoiding traffic perturbations.

Human presence on the road (12/0, Upstream, With Trace) was the event selected to test this conditioning and participants successfully acted as emitters, forwarders and final receivers at different test executions (all executions triggered manually).

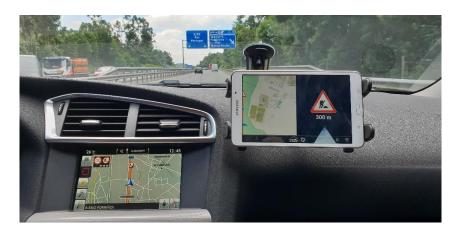
Figure 14: Different HMIs (serial-PSA- and nomadic-CTAG-) displaying same warning during a test trip

The main conclusion arisen from this session is that end-to-end interoperability among Spanish and French participants (both V2I and V2V) was validated as HMI results obtained during test executions matched with what expected according to the predefined event conditioning in the different scenarios. Besides this, it was also possible to:

detect a communication issue - at access layer level - in some of the Portuguese equipment; discuss on different message parameters configuration (e.g. event distance radius) that could cause functional issues even systems are interoperable; confirm that provision of traces and event history values is key to release reliable information to the driver.

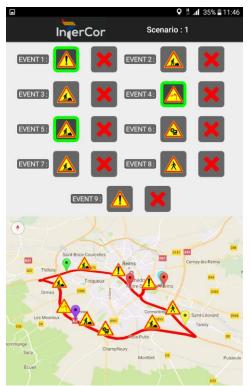
Figure 22 Screenshot of the Tablet Application

To obtain these logs, each participant was given an electronic tablet in order to get their individual results for every scenario execution.

For every participant in every scenario, the number of successes displaying or not the different events were logged (input provided taking into account what was expected according to the predefined event conditioning in the different scenarios).
