SCOOP Crosstests Evaluation – Second series

Deliverable

Publication Date: 30/12/2019

Document: SCOOP cross test report – Second series

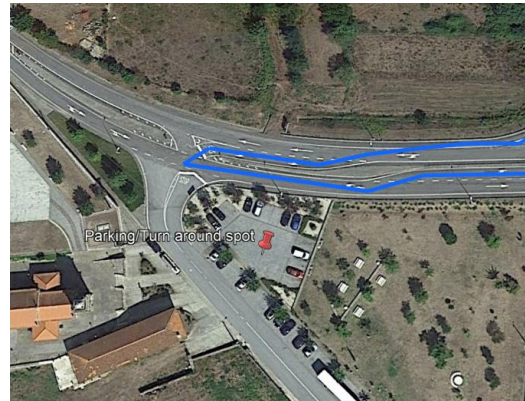
After exiting the A3 highway there is a parking lot where it is possible to comfortably stop before continuing the run.

Figure 9: Turn around or parking spot

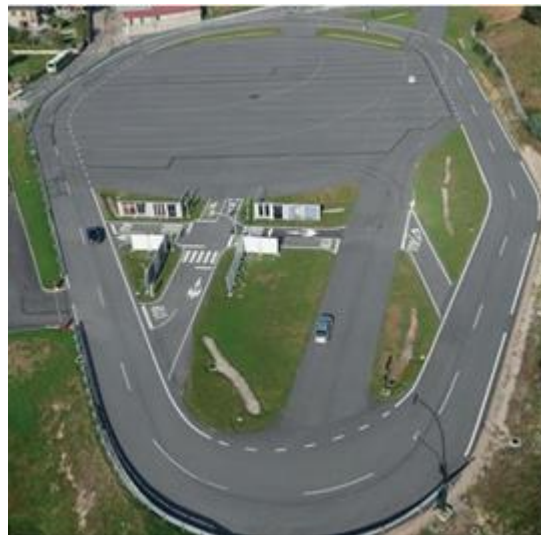
Figure 10: Test track at CTAG facilities

As done for the Xtest session carried out within W1, previous to on road tests, it was taken advantage of CTAG test track facilities to allow participants to perform some initial tests to validate their vehicle setups and configurations.

These tests were devoted to assure that all equipment in vehicles were correctly up and running and that every participant was visible to all others (both directly – ETSI ITS G5- and cellular-communication with corresponding National Node-).
